LitchField CT Post Office

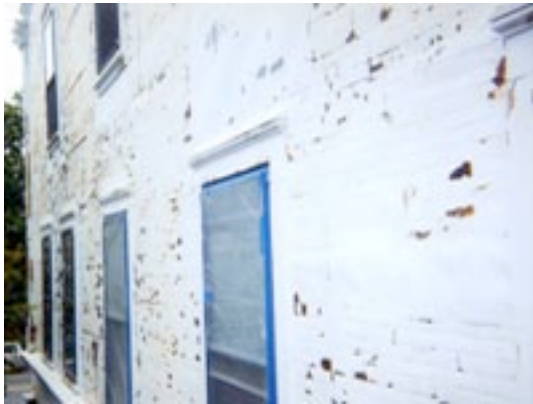
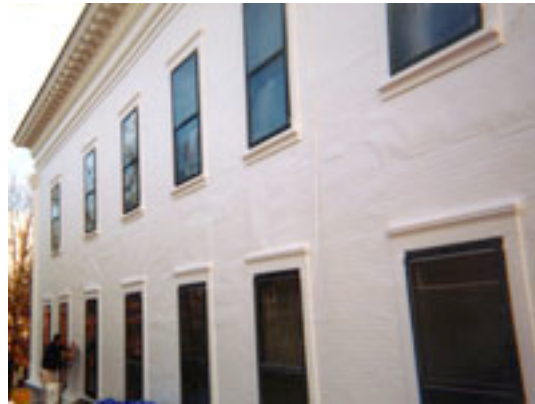
The Challenge: The LitchField Post Office is a Historic Building, which was built, in the late 1800s. The Building had badly peeling paint and also had rust bleeding through on one side where metal anchors were discoloring the painted surfaces. The owner wanted the surfaces stabilized and the rust dealt with while the Post Office continued to operate.

The Solution: An encasement system with a rust inhibitive primer was chosen to help stop the rust and to stabilize all of the painted surfaces. The building received a rust inhibitive primer coat followed by two coats of the encasement finish coat.
